\* 건축물명 :  
주7. 급식실

\* 건축물 소재지 :  
정읍시 학산로 89

\* 석면 조사 기관:  
(주)알파석면연구소

\* 조사일자:  
2021.01.14.  
~2021.01.18.

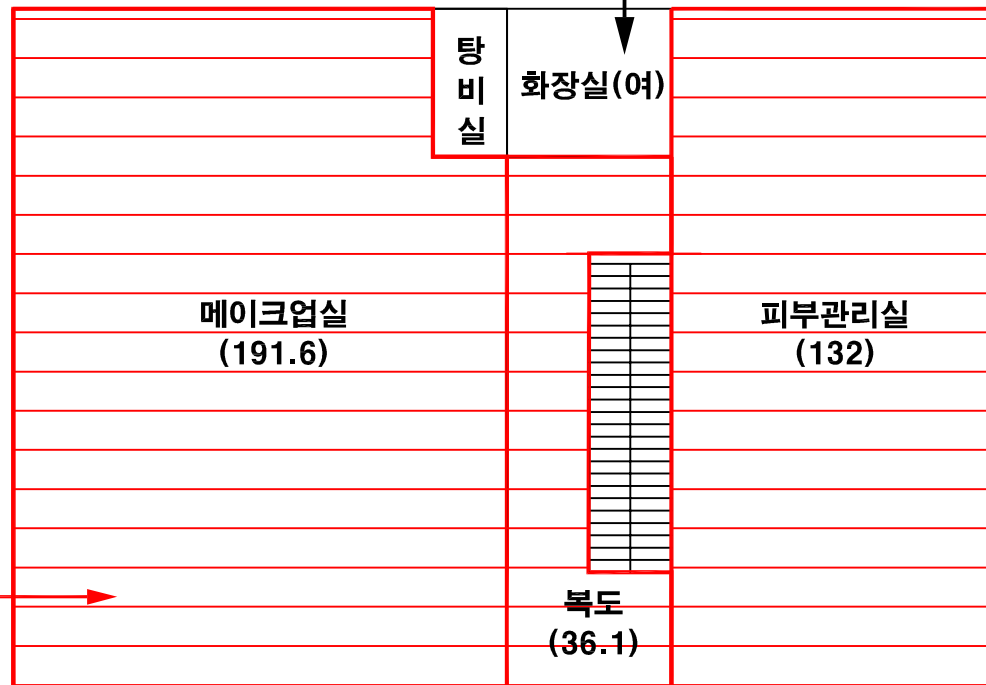
\* 도 면 번 호 : 21-0118-21

시료 번호	시료 채취 위치	건축 자재	동일 물질 구역	면적(㎡), 부피(㎥), 길이(m)	석면종류	함유량(%)	위해성 평가 점수	위해성 등급	관리 방안
A-24	메이크업실 천장 텍	스메이크업실, 복도, 피부관리실 천장	359.7 ㎡	백석면	5%	-	-	<해당없음.>
